AMMRC CTR 75-29

PARAMETRIC STUDY OF DIFFUSION  
BONDED BUTT JOINTS

SOLAR DIVISION OF INTERNATIONAL HARVESTER  
P.O. BOX 80966  
SAN DIEGO, CALIFORNIA 92138

FINAL REPORT - CONTRACT NUMBER DAAG46-75-C-0040

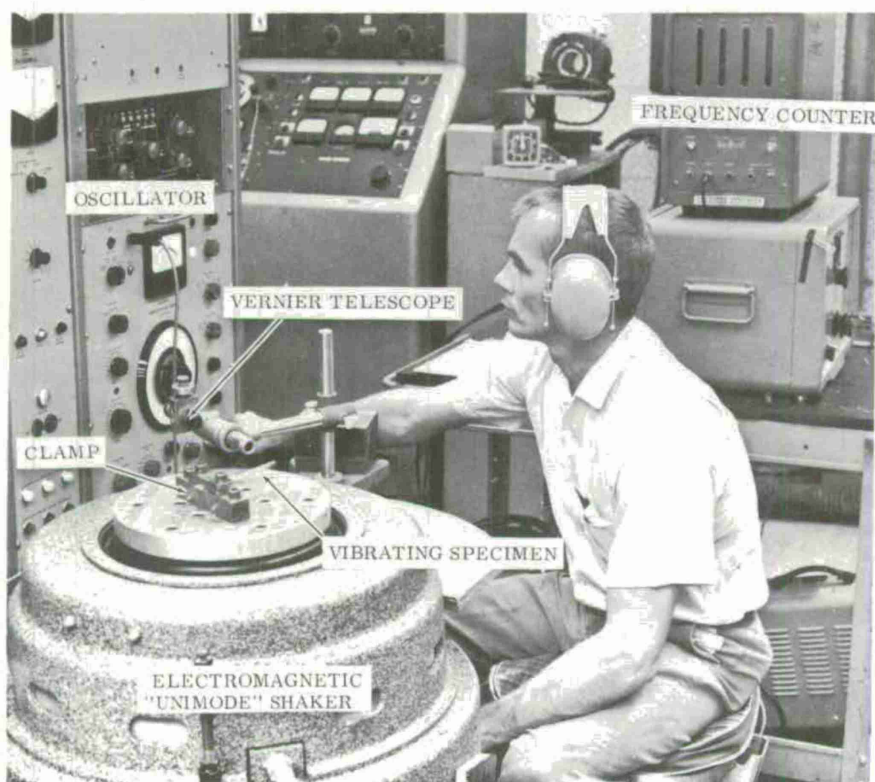
Figure 12. Resonant fatigue test apparatus.

was measured and controlled at 0.100 inch throughout the test. This deflection corresponds to 0.5% strain peak to peak and was chosen to produce failure in  $10^4$  to  $10^7$  cycles. The test setup with a fatigue test in progress is shown in Figure 12.

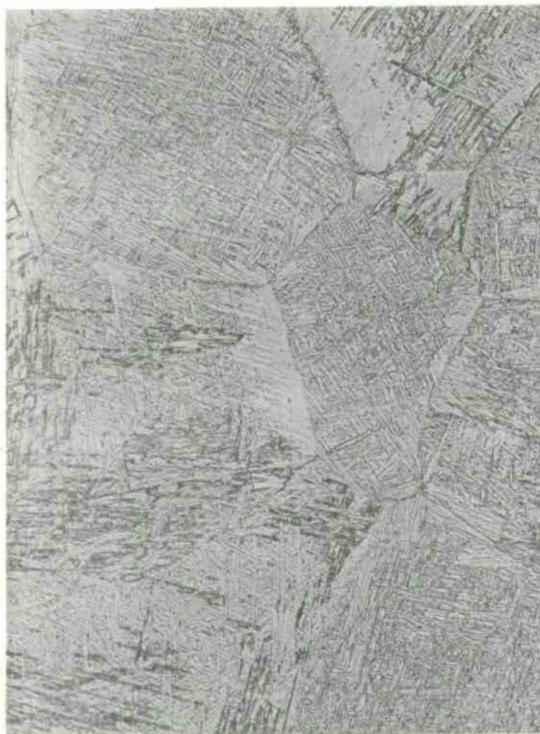
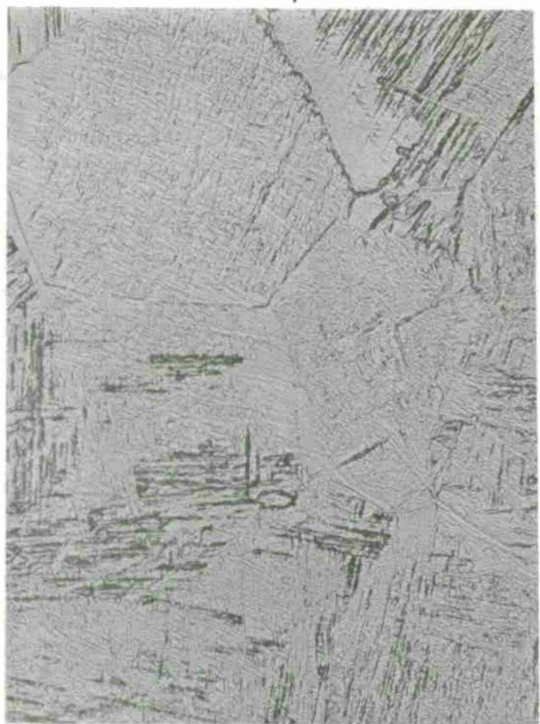
Etchant: 1 min Kroll's

Etchant: 2 min Kroll's  
+ 4 sec CSDB.

Magnification: 200X

Figure 13. Example of etched microstructure of CSDB joints (note severe etching required to reveal bond line). Magnification: 200X

Figure 13 shows examples of the microstructure revealed with the two etchants. In both cases, severe overetching was necessary to reveal the bond line. The bond line is apparent only because the indications are lined up. As can be seen in Figure 13, other areas in the general microstructure are more severely etched.

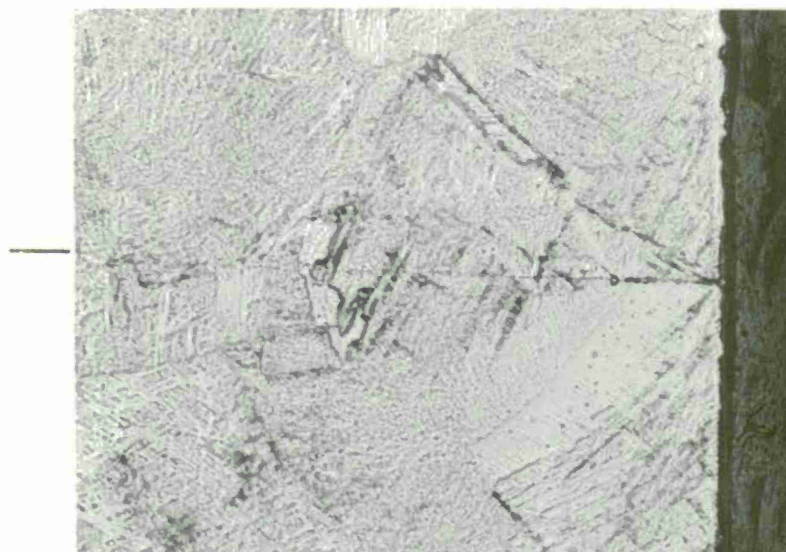
I = 11,200 amps (std)  
S = 3.75 in./min (std)  
F = 2025 lbs

5T, 5T bend  
142 ksi UTS  
 $3 \times 10^5$  cycles fatigue

Figure 23. Microstructure in joint region showing typical examples of good joint quality based on mechanical tests.

Etchant: 2 min Kroll's + 4 sec CSDB.

Magnification: 200X.

Specimens from the entire matrix of bonding parameters were examined metallographically. All specimens were etched identically using the heavy etch discussed previously. Examples of the joint zone for various bonding parameters are shown in Figures 23-25. The three figures show respectively, good, marginal and inadequate quality joints based on mechanical tests. The mechanical properties, as well as bonding parameters, are given with each photomicrograph. A cursory comparison of the figures indicates that there is little apparent correlation between mechanical strength of the joints and severity of etching at the bond line. Grain growth across the bond line has occurred in all cases. Also, in all cases the region of heaviest etching along the bond line is shown, except for Figure 23a this corresponds to the bottom surface of the panel. Another visual evaluation of joint quality could be made from examination of the heat affected zone through the thickness of the panel. A direct correlation was found between shape of the heat affected zone and joint quality. This correlation is shown schematically in Figure 26. For good joint quality, the heat affected zone was approximately 1 inch wide throughout the thickness of the panel and symmetrical about the bond line. In the region of marginal joint quality, due to lack of heat, the heat affected zone was smaller on the bottom surface. This is consistent with the bonding parameter variation in that marginal bonding occurred as effective heat input was reduced. An example of the

Since the as-received Ti-6Al-4V sheet varies in thickness along its length, a height difference in the joint region can occur in the prebond setup. Examples of this type of offset are shown in Figures 23a, 24a and is most marked in Figure 25a. When the bonding parameters are such that a high quality joint is produced the evidence of this offset is almost completely eliminated and strength of the joint is not appreciably affected (Figure 23a). However, as the bonding parameters are moved away from optimum, this offset may act as a stress riser to reduce strength or cause flat fracture in an otherwise high quality joint. This appears to be the case in Figure 25a. The etched bond line, although fairly continuous, does not contain any heavily etched regions or show lack of bonding (lack of grain growth) although flat fracture occurred in all test conditions.

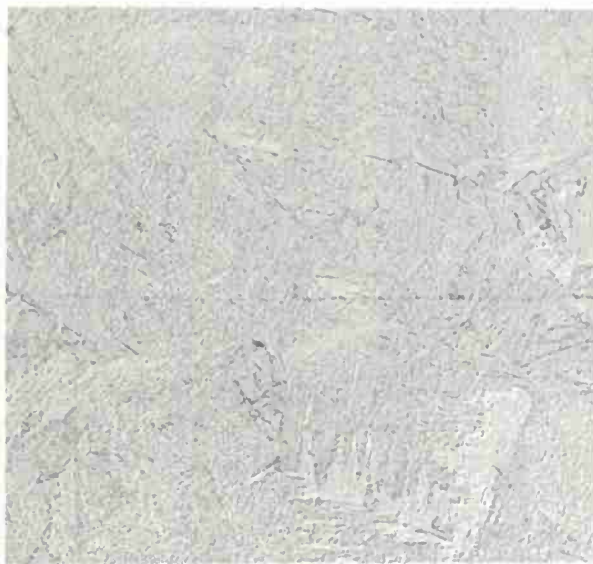
I = 11,530 amps  
S = 4.31 in./min  
F = 2200 lbs (std)

5T, FF bend  
141 ksi UTS  
 $1 \times 10^6$  cycles fatigue

I = 11,530 amps  
S = 4.81 in./min  
F = 2025 lbs

5T, FF bend  
138 ksi UTS-FF  
 $1 \times 10^5$  cycles fatigue

Figure 24. Microstructure in joint region showing typical examples of marginal joint quality based on mechanical tests.  
Etchant: 2 min Kroll's + 4 sec CSDB.  
Magnification: 200X.

The foil in a good quality joint would add strength to the joint region due to increased cross section. However, for bonding conditions where insufficient heat and pressure were available to completely bond the foil to the part, voids such as those shown in Figure 24a could act as stress risers and effectively decrease the strength of the joint. An investigation to determine the effect of the foil on joint strength was not within the scope of this program.

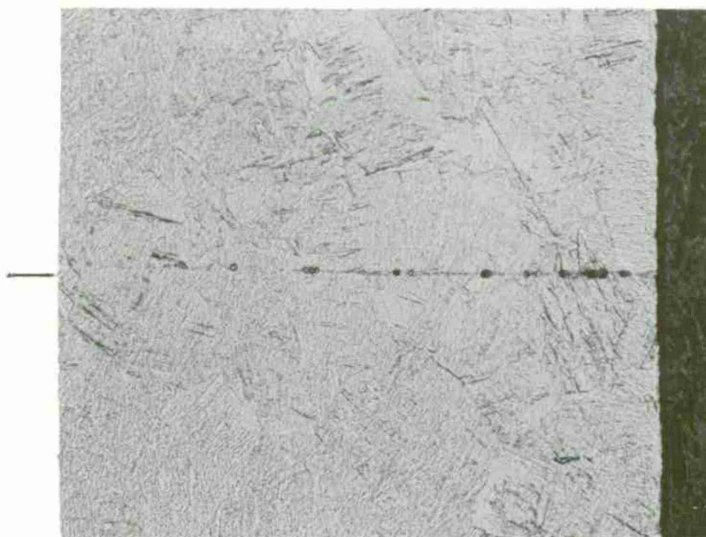
I = 11,200 amps (std)  
 S = 4.81 in./min  
 F = 2200 lbs (std)  
 5T, FF bend  
 131 ksi UTS-FF  
 $8 \times 10^4$  cycles fatigue-FF

I = 10,528 amps  
 S = 4.81 in./min  
 F = 2200 lbs (std)  
 5T, FF bend  
 128 ksi UTS-FF  
 0 cycles fatigue-FF

Figure 25. Microstructure in joint region showing typical examples of inadequate joint quality based on mechanical tests.  
 Etchant: 2 min Kroll's + 4 sec CSDB.  
 Magnification: 200X

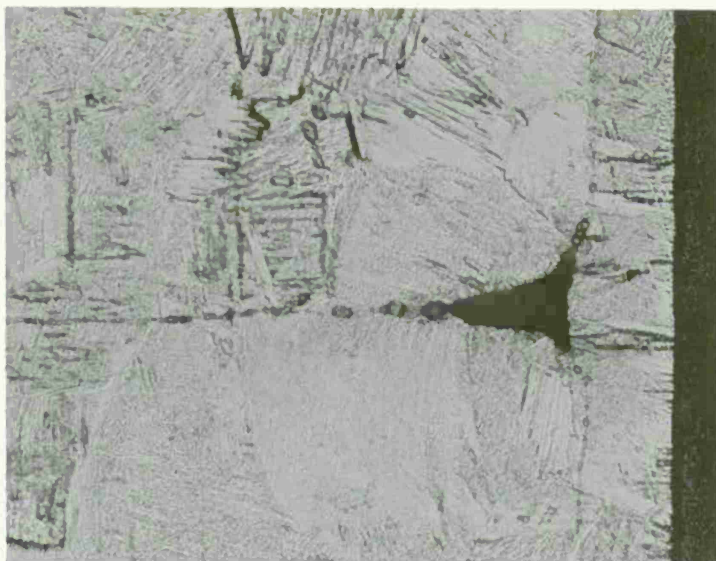
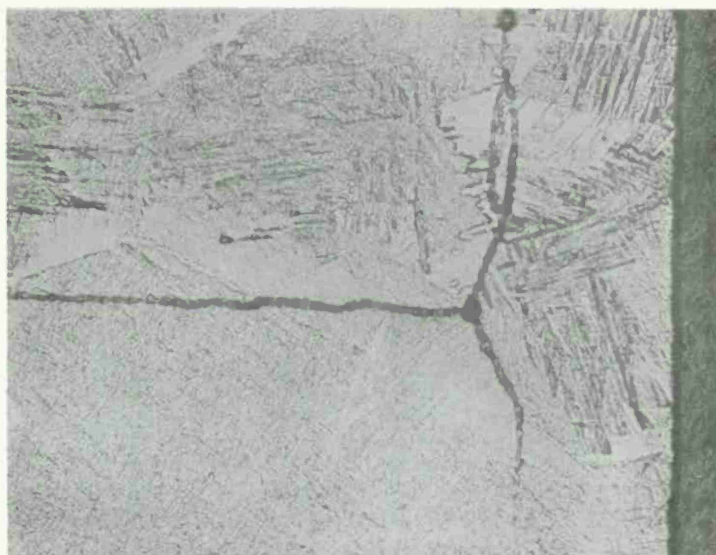
a) 0.005 inch notch (^) bottom  
Magnification: 200X

b) 0.005 inch notch (v) top  
Magnification: 200X

c) Offset with 0.005-0.010 inch  
Ti shims  
Magnification: 150X

Figure 28. Effect of geometric variables on joint quality  
Etchant: 2 min. Kroll's  
+ 4 sec CSDB.  
(Sheet 1 of 4)

Examples of the joint for the various geometric variables are shown in Figure 28(a-h) in the same order as Table 3. Figure 28a and 28b correspond to the notched panel. The dimension of the original notch is also given. It is interesting to note that the notched top surface was almost completely filled in during bonding while the bottom notch was only partially removed.

From the appearance of the joint in Figure 28c, it is not apparent why flat fractures were found (Table 3) for a joint offset by 0.005-0.010 inch. And, as discussed later, it is uncertain why this condition affected the joint more severely than greater offsets.

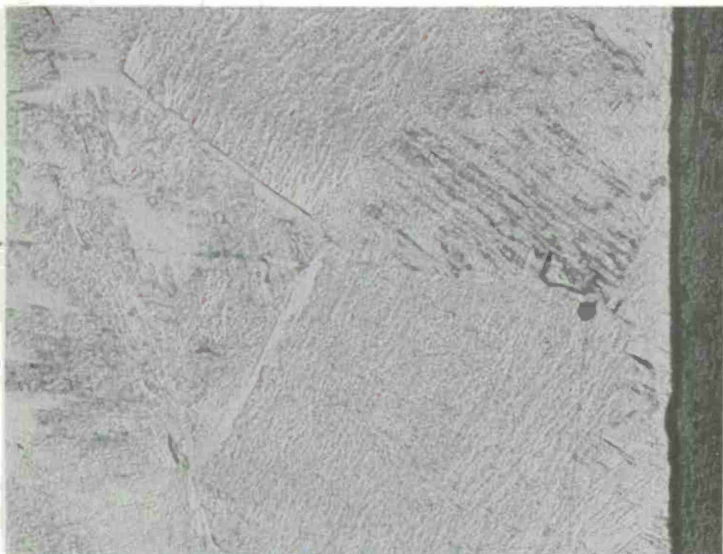
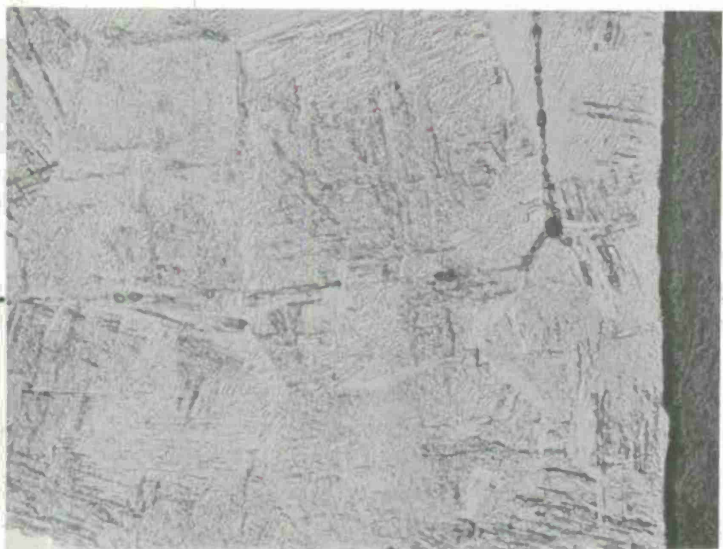
d) Round corner (8 min acid clean)

e) Round corner (4 min acid clean)

f) Offset with 0.010-0.020 inch Ti shims - bottom

Figure 28. Effect of geometric variables on joint quality

Based on appearance of the joint region, the rounded corner condition (Figure 28e and 28h) had little effect on joint quality.

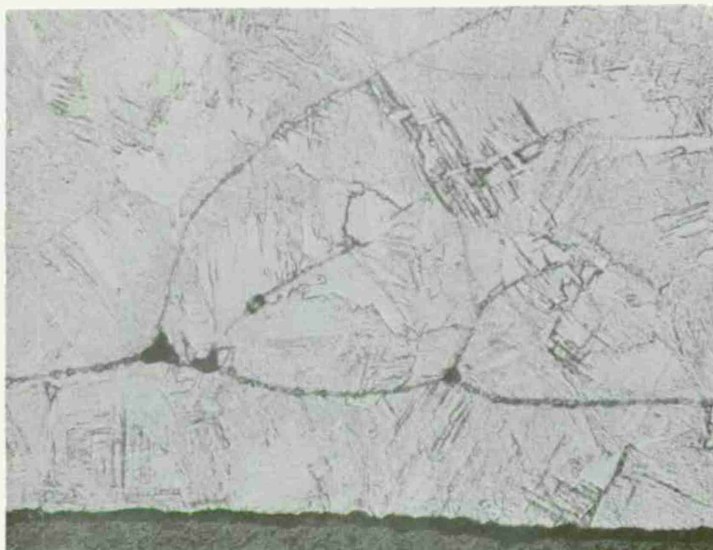
g) Offset with 0.020-0.040 inch  
Ti shims.  
Magnification: 150X

Original offset  
at 150X

Ti shims 0.1 inch from bond line

Figure 28. Effect of geometric  
variables on joint  
quality  
Etchant: 2 min Kroll's  
+ 4 sec CSDB.  
(Sheet 3 of 4)

The artificial offset condition resulted in a remarkably good bond, considering the severity of the mismatch. Figure 28g shows examples of the joint condition at the location of the 0.020 inch shim. Height of the offset at 150X is also given for comparison. In addition to the butt joint, the bonded Ti shims located 0.1 inch away from the joint are shown. Considerable forging of the material has occurred, as evidenced by the location of the bond line at the top of the panel.

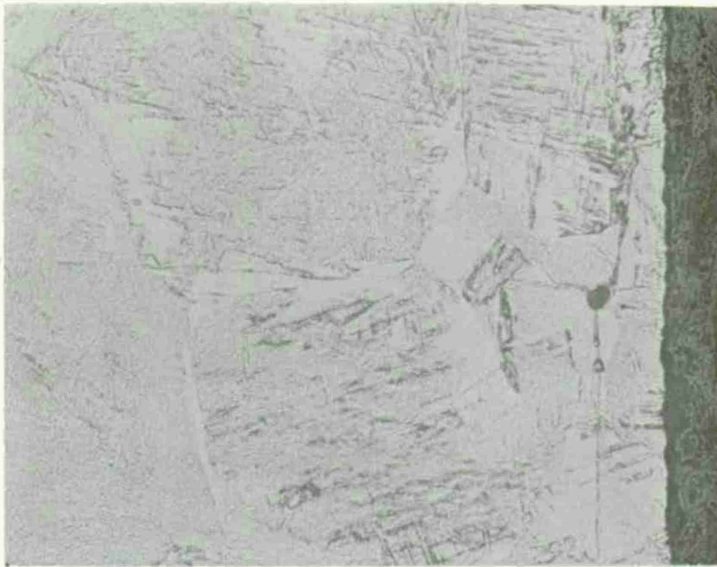
a) Used acid (Ti-6Al-4V only)

b) Stored 48 hrs prior to bonding

c) Plant acid

**Figure 30.** Effect of preparation variables on joint quality.  
Etchant: 2 min Kroll's + 4 sec CSDB.  
Magnification: 200X

Examples of the microstructure in the joint region are shown in Figures 30-32 for the various preparation and contamination variables. Low magnification views are given to provide a comparison of overall joint quality. Observations of the bond line at high magnification will be presented in Section 4, where flat fracture characteristics are discussed. Figure 30 shows a comparison of joint quality resulting from variations in prebond preparation procedures. The standard overetching technique

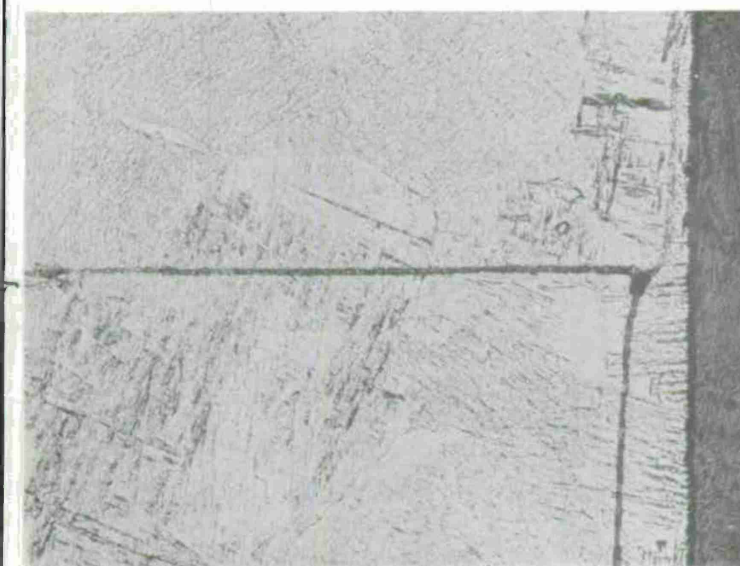
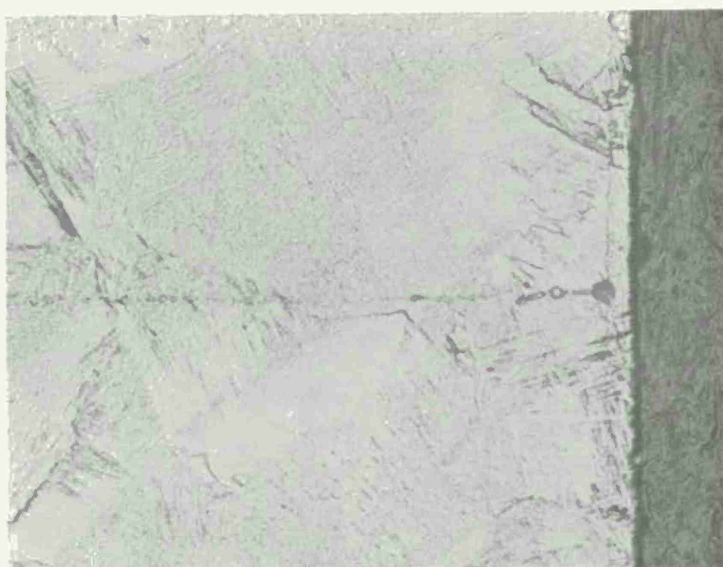
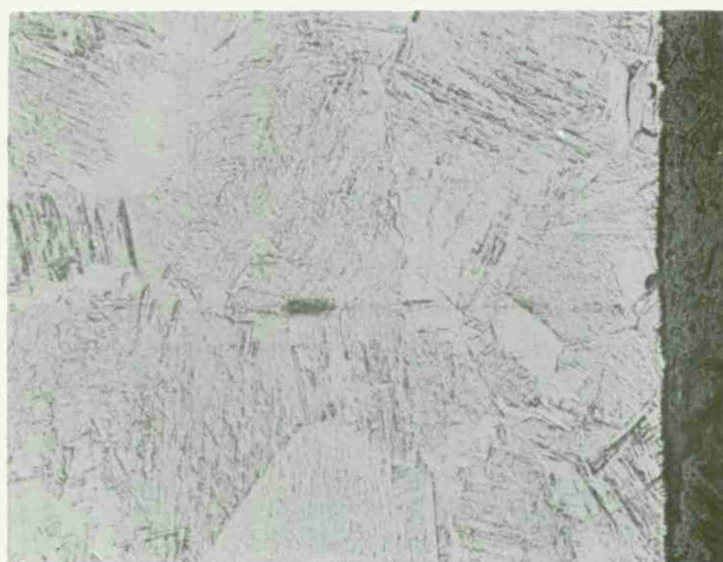
a) Lint

b) Greasy fingerprints

c) Tap water

Figure 31. Effect of contaminants on joint quality.  
Etchant: 2 min Kroll's  
+ 4 sec CSDB.  
Magnification: 200X  
(Sheet 1 of 2)

d)  $\text{Al}_2\text{O}_3$  grinding media

e) Dust from bonding wheel  
(Ag, Mo-oxides)

Figure 31. Effect of contaminants on joint quality. Etchant: 2 min Kroll's + 4 sec CSDB. Magnification: 200X. (Sheet 2 of 2)

The effect of various contaminants on joint quality is shown in Figure 31 in order of decreasing severity based on mechanical test results. Again, the overetched condition was necessary to reveal the bond line. Foreign particles in the bond line were not observed at these magnifications. There is a general correlation between etched bond line appearance and mechanical test results.

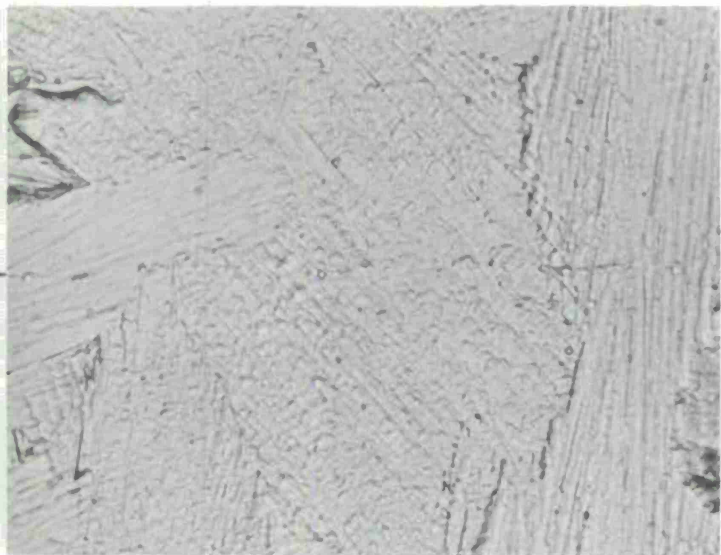
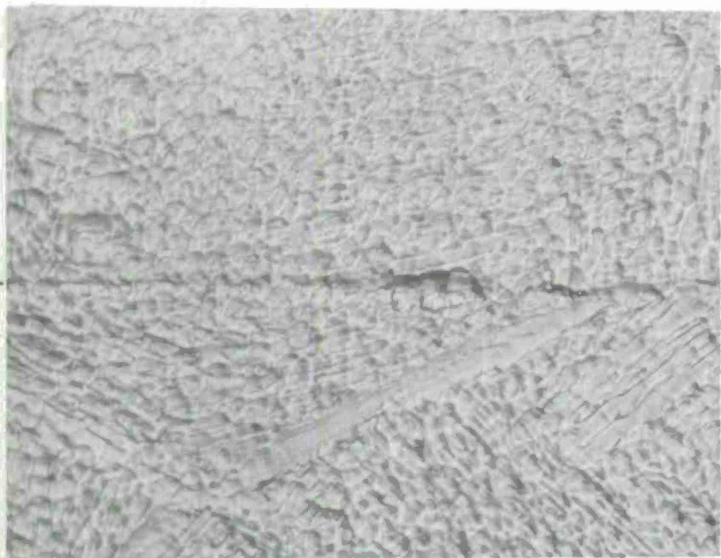
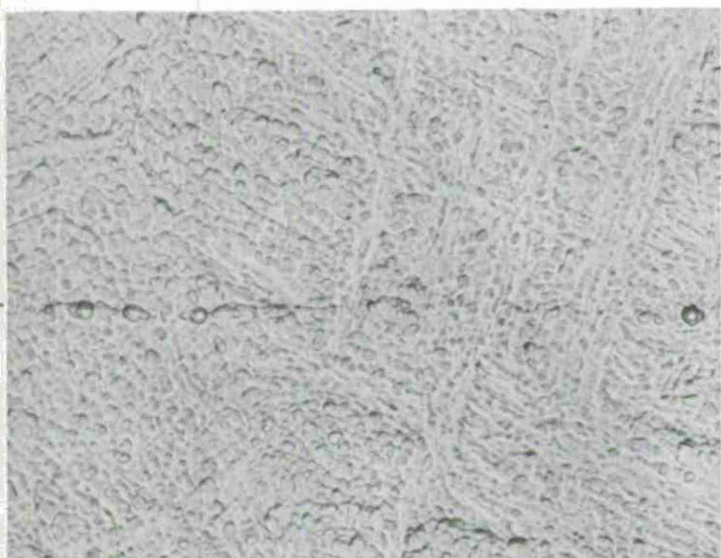
a) 1350° F

b) 1600° F

c) 2000° F

**Figure 33.** Effect of heat treatment on bond line indications for good quality joint.  
Etchant: 2 min Kroll's + 4 sec CSDB.  
Magnification: 1000X.

Examples of the resulting microstructures are shown in Figures 33 to 36. Except for fingerprint contamination, a heavy overetch condition was necessary to reveal the bond line indications. For comparison purposes, the standard heavy etch was used for all the photomicrographs. In all cases, the area of heaviest etching is shown. No difference in bond line appearance was observed with the three heat treatments for a good quality joint (Figure 33). This indicates that the specie responsible for the etched indications is not readily soluble in the titanium matrix. In the absence of diffusion data, Table 5 lists some of the potential gaseous contaminants and their respective atomic sizes and solubilities in titanium. Small amounts of hydrogen, carbon, oxygen and nitrogen would be readily dissolved at both 1600 and 2000° F. These elements are considered interstitial due to their relatively small size compared with titanium atoms (1.46Å). Argon, sulfur and chlorine are expected to behave as substitutional elements and their solubility in titanium is probably quite low and consequently diffusion rates are expected to be very low. Compound formation

Figure 35 shows a poor quality joint which failed by flat fracture in the mechanical tests. Again, there is no appreciable difference in the bond line indications for the three heat treatments. Although the size of the indications is essentially the same as for a good quality joint (Figure 33), the number of indication is much larger, giving an almost continuous decoration of the bond line. This observation suggests that the occurrence of flat fracture is not dependent on the size of indications of the bond line, but on their number. This particular panel was bonded using low-heat processing parameters.

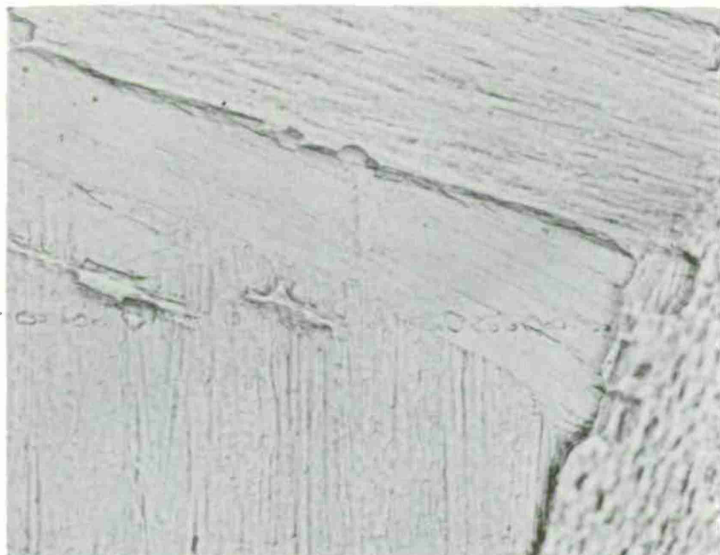
a) 1350° F

b) 1600° F

Figure 34. Effect of heat treatment on bond line indications for vacuum bonded panel. Etchant: 2 min Kroll's + 4 sec CSDB Magnification: 1000X.

c) 2000° F

Additional support for this hypothesis is apparent from examination of the heat treated samples for the vacuum bonded panel (Figure 34). Again, there is no obvious difference between the etched bond line indications as a function of heat treatment. More important, however, is the observation that the size and number of the indications is less than that evident in the air bonded panel (Figure 33). The only difference in bonding procedure between the two panels was the bonding atmosphere and therefore, the size and number of indications should be a direct function of the amount of trapped gas.

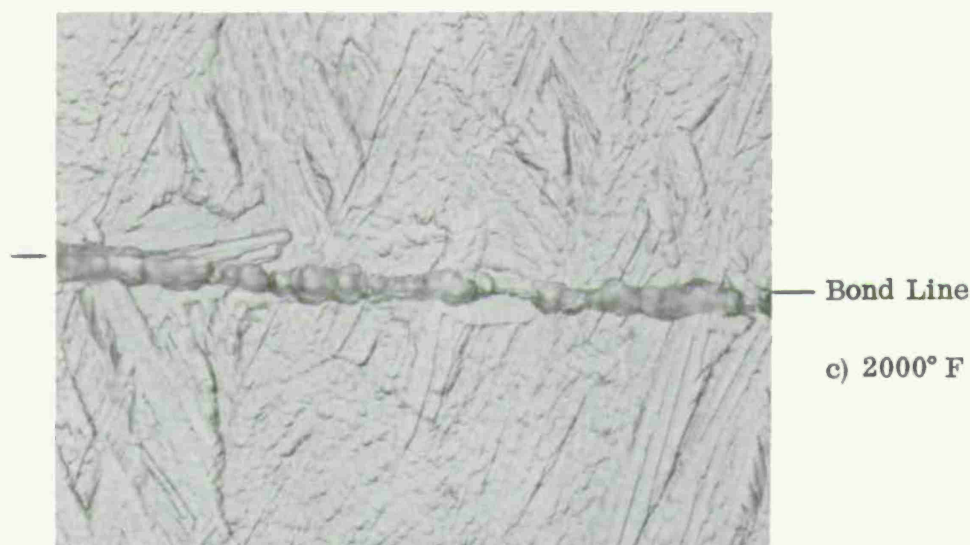
**Figure 36.** Effect of heat treatment on bond line indications for fingerprint contaminated panel.  
Etchant: 2 min Kroll's + 4 sec CSDB.  
Magnification: 1000X.

The panel contaminated with greasy fingerprints did show improvement in bond quality with heat treatment (Figure 36). However, the joint quality would still be considered poor after one hour at 2000° F. It is possible that further annealing would result in increased quality. The major contaminants in this bond line are probably carbon and hydrogen resulting from decomposition of the grease, with minor amounts of chlorine and sulfur from perspiration. During CSDB processing, the time at temperature is only one to two seconds and it is probable that solution of the contaminants was not possible for this short period of time. However, the one hour heat treatments allowed solution of the rapidly diffusing species.

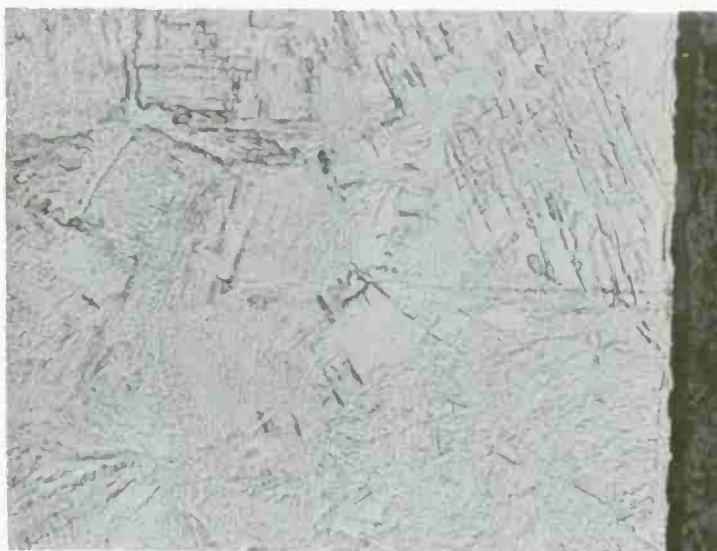
Area of ultrasonic indication -  
Category 3 or 4.

Etchant: 2 min Kroll's + 4 sec  
CSDB.

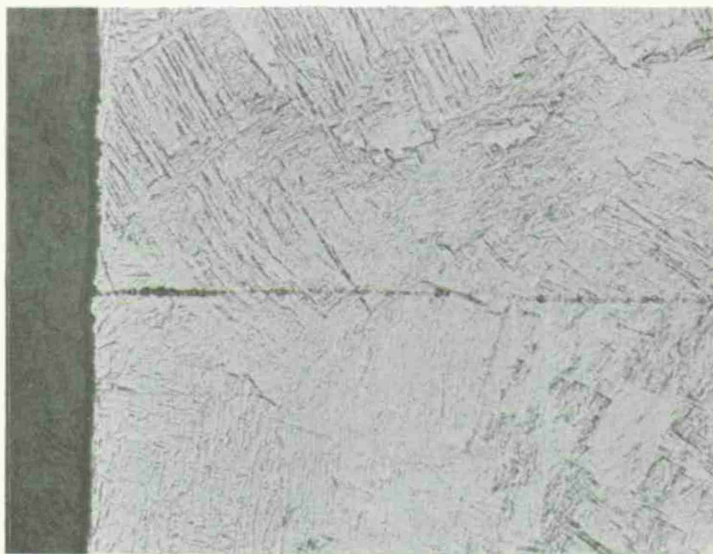
Area of ultrasonic indication -  
Category 4 or 5.

Etchant: 2 min Kroll's + 4 sec  
CSDB.

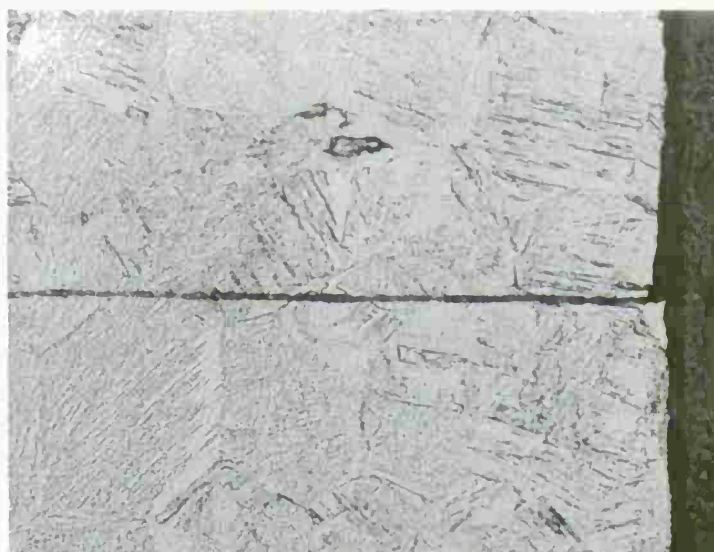
Area of ultrasonic indication -  
Category 7.  
Etchant: 2 min Kroll's + 4 sec  
CSDB.  
Magnification: 200X.

Figure 49. Ultrasonic inspection of CSDB panel.

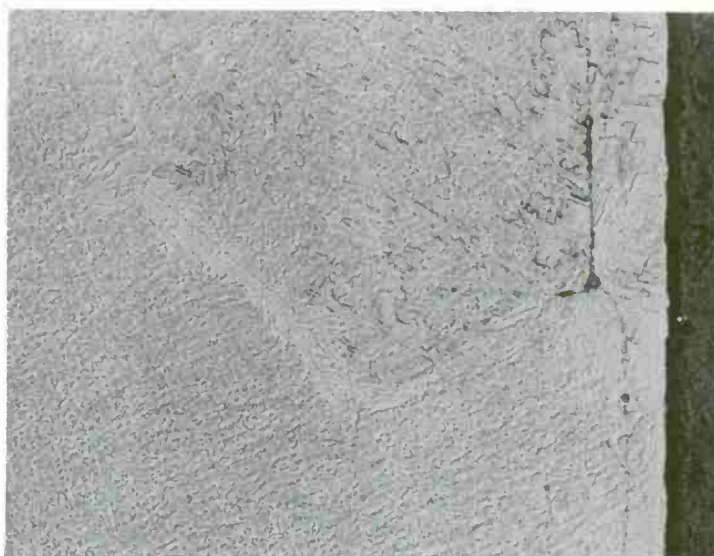
Area of ultrasonic indication - Category 9.

Etchant: 2 min Kroll's + 4 sec CSDB.

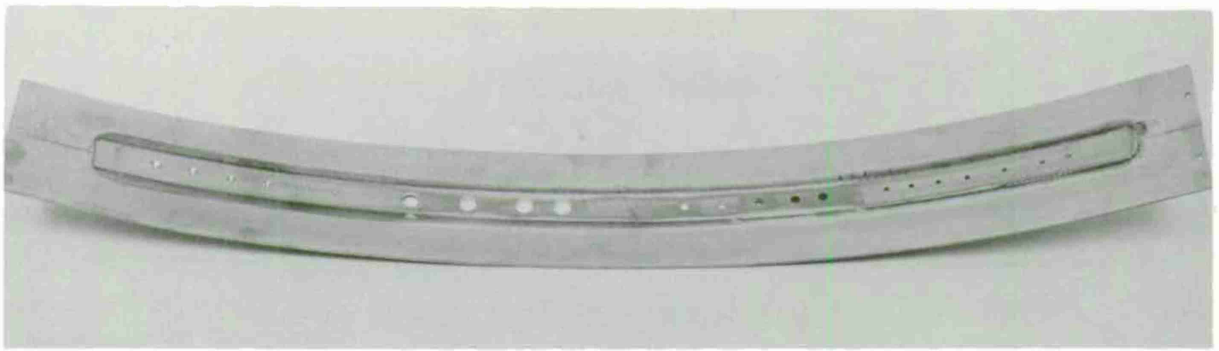
Figure 55. Panel prepared to evaluate repair techniques.

To establish and evaluate repair techniques, a series of different size holes, 1/8 inch, 1/4 inch and 1/2 inch diameter were drilled and reamed through a standard panel to simulate the removal of voids or inclusions. Surface damage was simulated by 1/8 inch, 1/4 inch and 1/2 inch diameter drill points into the surface of the panel, approximately 1/16 inch deep. Figure 55 shows the panel before repair.

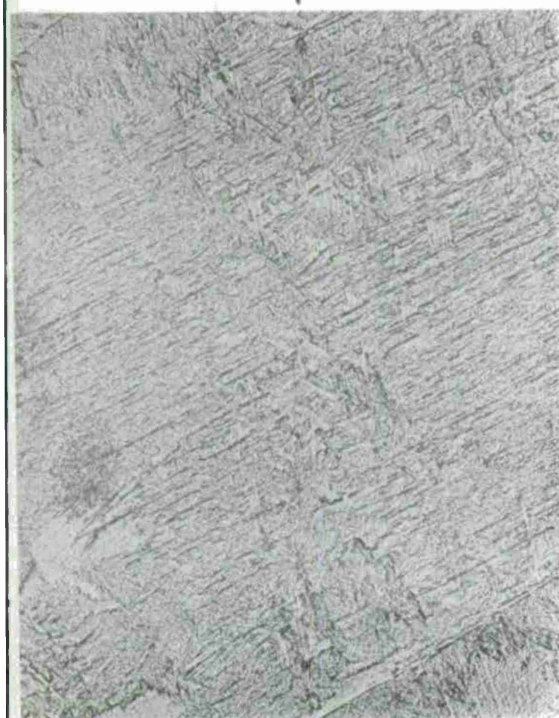
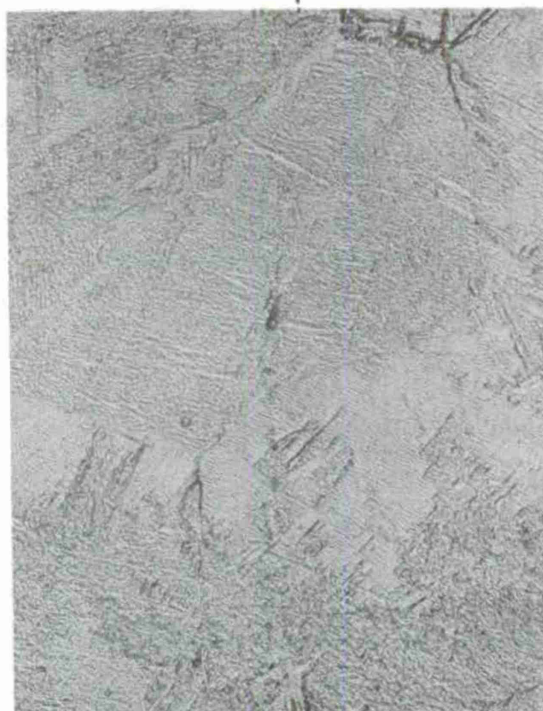
a) Magnification: 8X.

← Plug interface →

b) Magnification: 200X.

Figure 57. Microstructure of repair section containing 0.25 inch diameter plug.  
Etchant: 2 min Kroll's + 4 sec CSDB.

Examples of the microstructure in the repair areas are shown in Figures 57 and 58. The location of the plugs was apparent from grain structure differences as shown in Figure 58a. As can be seen in the photomicrographs, a good to moderate quality joint was formed at the plug-panel interface. Grain growth across the bond line was noted throughout the section and the special overetching method was required to reveal any indication of the bond line. An example of the joint region in the panel bonded twice is given in Figure 59. The only noticeable difference in structure from a single pass panel is an increase in grain size.

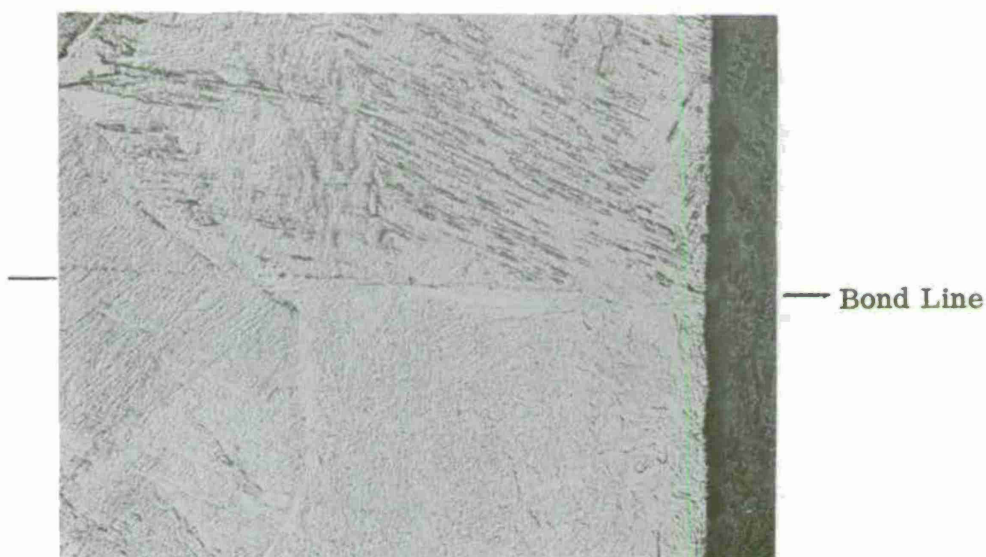
Figure 59. Microstructure of joint region after two standard CSDB operations.  
Etchant: 2 min Kroll's + 4 sec CSDB. Magnification: 200X.
